Mercury Control by EPRI MerCAP™ Process

MEGA Symposium
August 29, 2006

Juliana Kyle, Southern Company
Kevin Fisher, Apogee Scientific

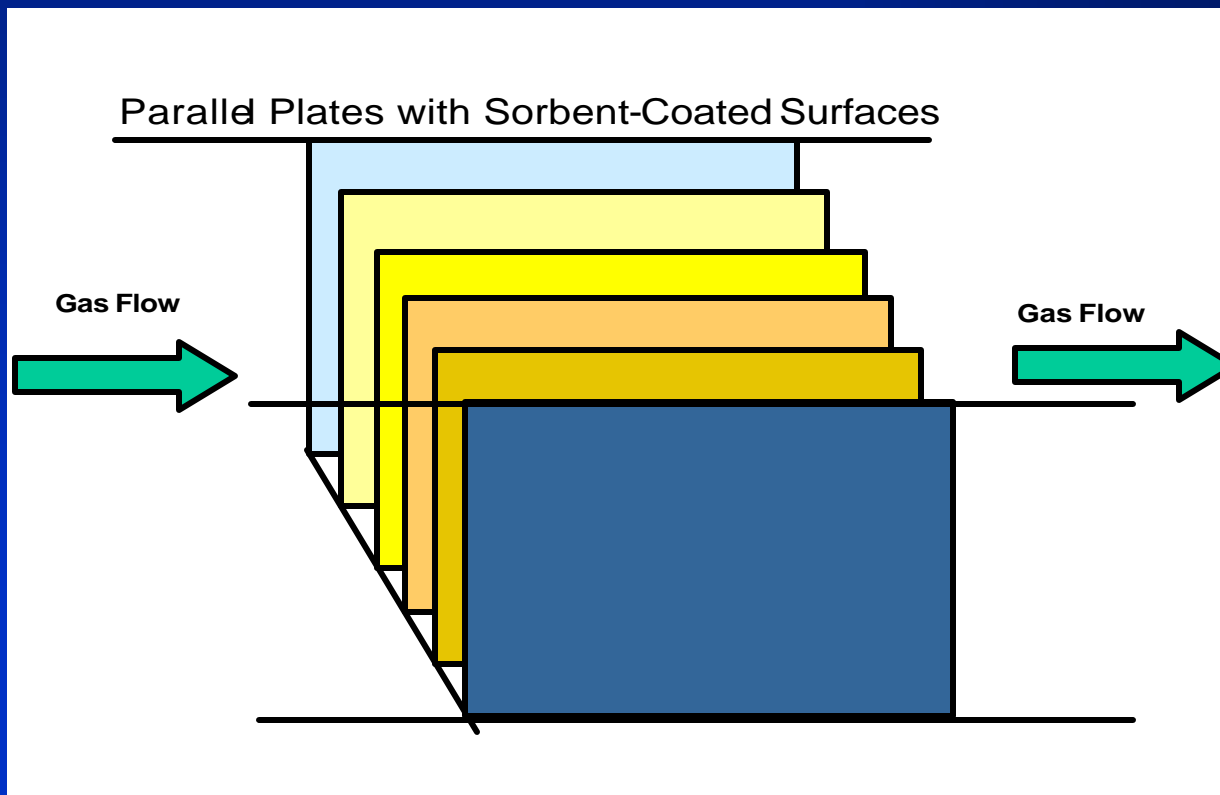
- Fixed sorbent structures to adsorb mercury
 - Gold substrates

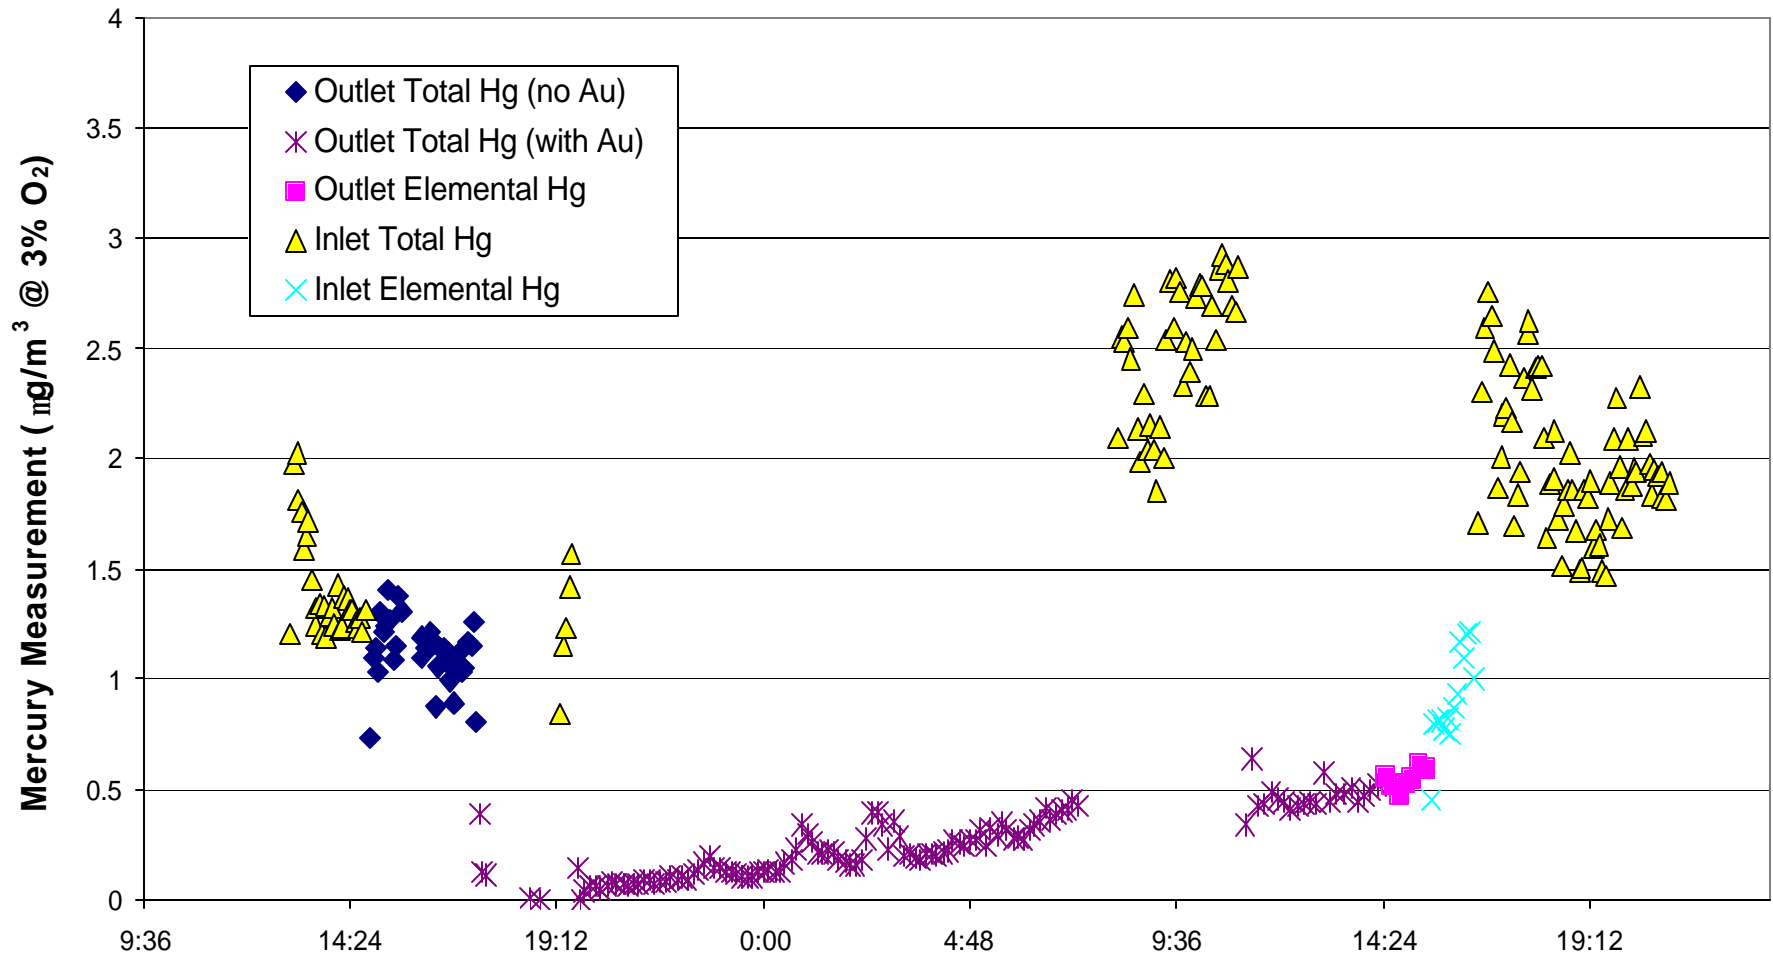
Initial Results (Original Substrates)

- | **Baseline Monitoring**
 - **No effect of reactor housing on mercury**
- | **Initial Mercury Measurements**
 - **Showed high mercury removal possible**
- | **Fan Failure**
 - **Acidic Flue Gas backed up through system**
 - **Corroded substrates**
- | **System re-routed to avoid high pressure drop**
 - **Substrates replaced and restarted July 2006**

- | Initial Results indicate high level of mercury removal is possible
- | Acidic conditions in flue gas corrode gold and stainless steel substrates
- | Material build-up on gold surface inhibits mercury adsorption
 - Possibly gypsum fines that pass through the mist eliminator
 - Effect of flue gas flow rate not evident when plates are fouled
 - Wash system demonstrated improvement in mercury removal in short section of gold
- | Ontario Hydro confirmed results seen with SCEMs

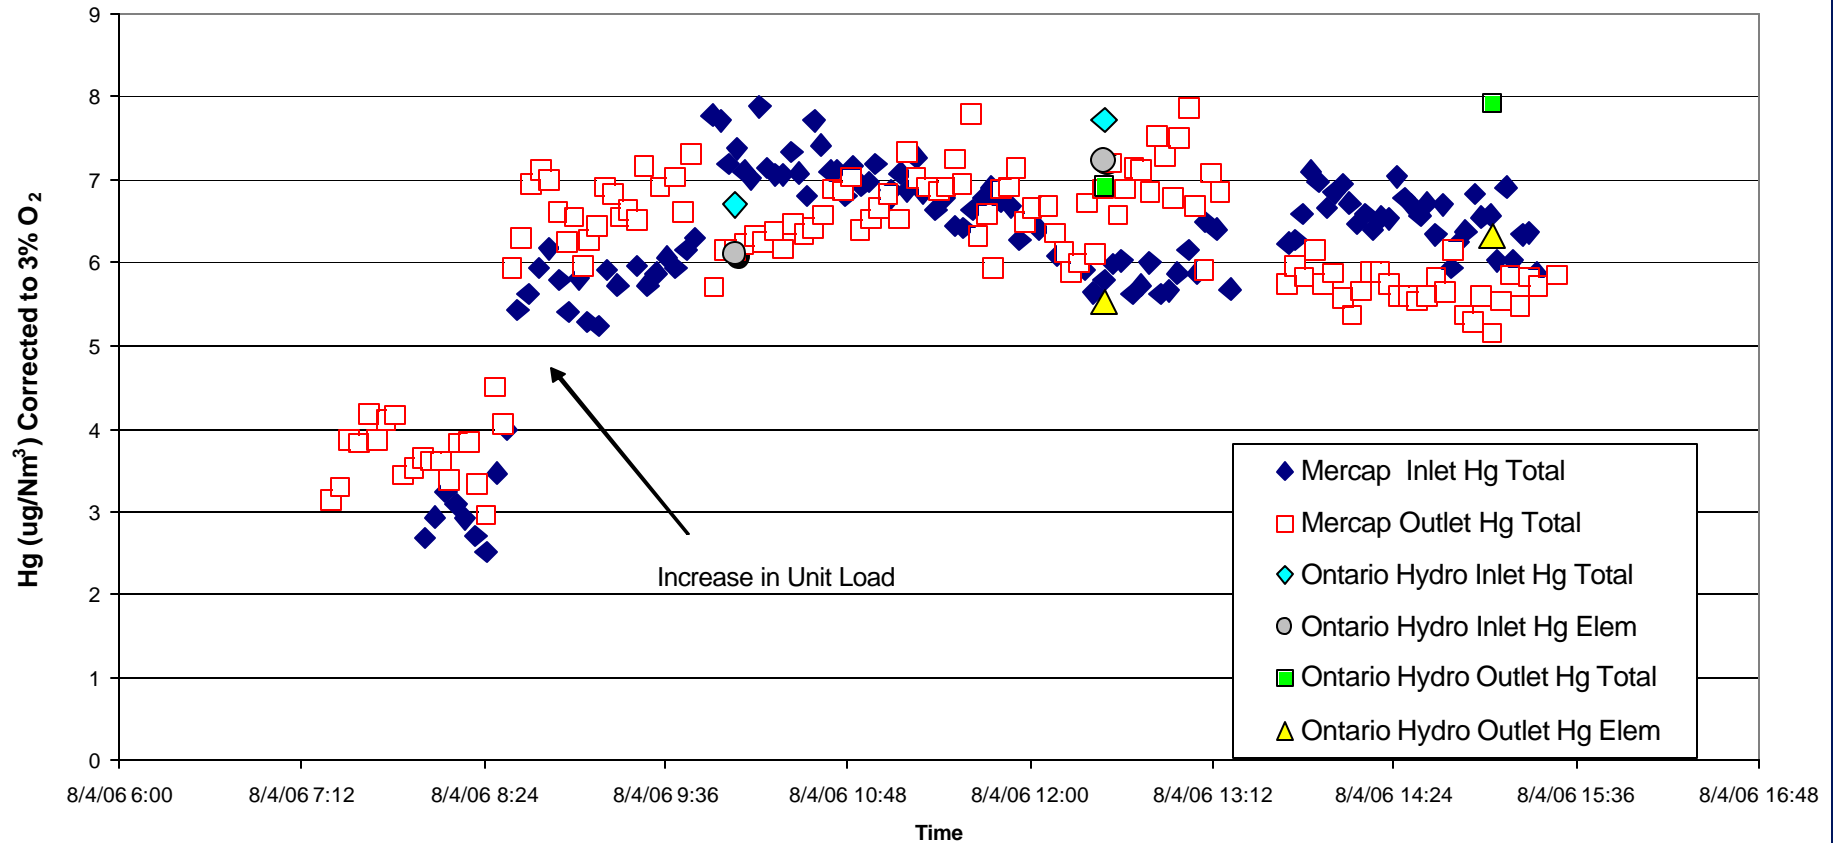
Results (New Substrates)

Yates MerCAPTM Mercury Measurements - SCEM and Ontario Hydro
520 Hours of Service

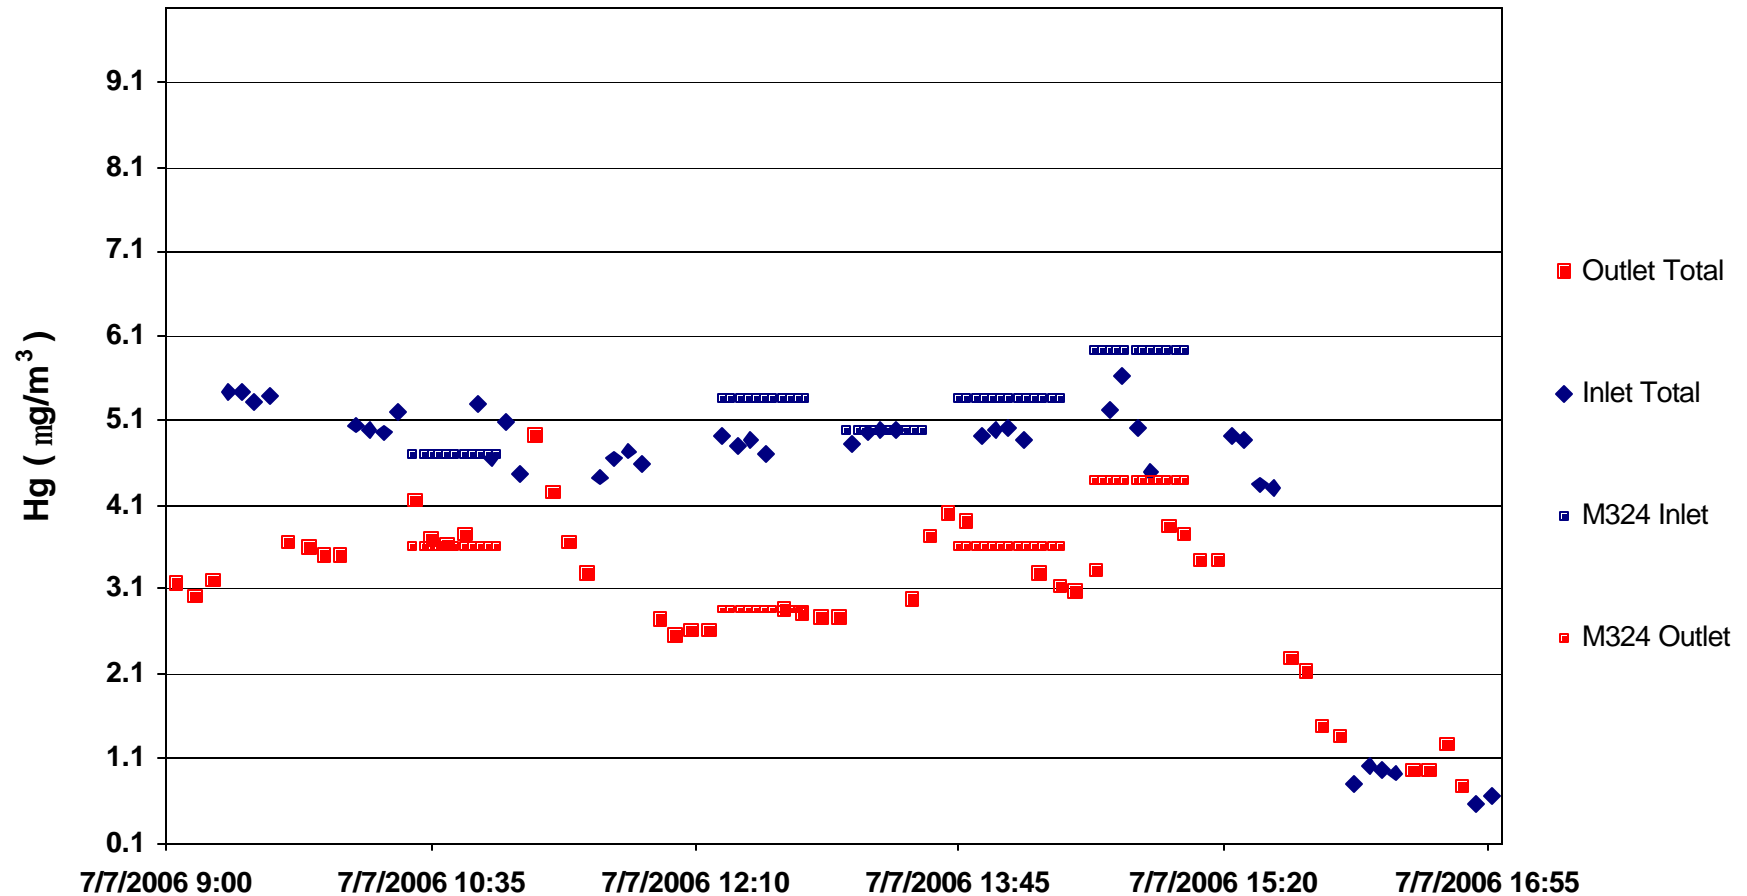
GRE Stanton Station – FF/SDA Installation Recent Work

- 22nd Month of service time
- Method 324 Measurements conducted to verify Hg CEM results
- Removal remains variable depending on gas temperature and lime/slurry feed-rate
- 40 – 50% removal observed after nearly 2 years of continuous treatment service
